Savina Technical Service Bulletin # 7

Re: Replacement of some internal TSI flow sensors

Date: March 21, 2002

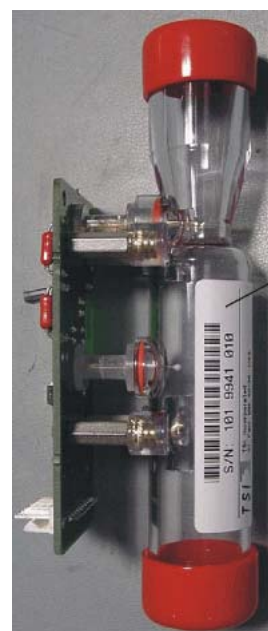
Reason: Alarm “Flow measurement failure !!!” may occur on some devices after a longer time of operation caused by drifting TSI flow sensors P/N 8413579. Affected sensors are labeled with the following serial numbers on the flow sensor housing (type – year / week – S/N produced on this date):

101 – 99 41 – 010 (week 41 in 1999)
through
101 – 01 10 – 014 (week 10 in 2001)

To avoid the alarm “Flow measurement failure !!!” replace all TSI flow sensors produced between week 41 in 1999 through week 10 in 2001 in affected devices. The TSI flow sensor can be replaced after removing the cover plate on the Savina back side.
